STUDY OF THE INFLUENCE OF DOOR INTRUSION VELOCITY IN LATERAL COLLISIONS: BIOMECHANICAL RESULTS

FCA Group – Fiat Automóveis S.A

PUC Minas Master Program – Pontifícia Universidade Católica de Minas Gerais

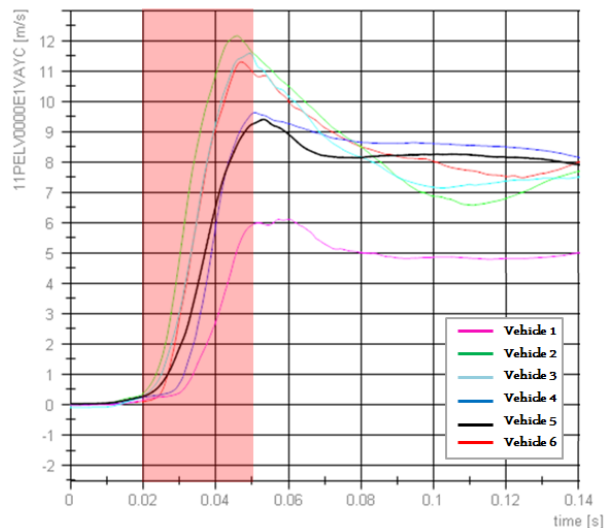
Figure 3 – Side impact benchmarking results for pelvic acceleration.

The method definition was made after a evaluation of 6 vehicles from different brands and segments in the side impact and theirs results. Using a range of vehicle mass (from 900 to 1300kg), brands and segment (from A to C). It was observed that due to the standard test setup, vehicles followed a standard behavior regarding to the pelvis results. The acceleration ramp for all the evaluated cases remained for 25ms. It means that dummy pelvic area remains in contact with door panel during a standard period as demonstrated in Fig.3.

The benchmarking analysis demonstrated that the range of door intrusion velocity has a substantial variation when comparing different masses and vehicle structural behavior. Among all the results found it were selected some of them, with the intention of having the worst, the best and intermediate biomechanical performances.

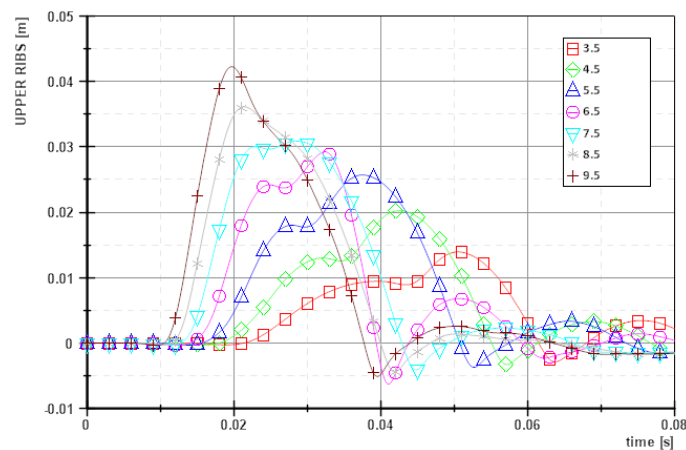
Figure 5 – Upper rib biomechanical results from different tested vehicles.

MADYMO simulation indicated the biomechanical results according Latin NCAP 2016 lateral impact protocol for all door intrusion velocity. Figures 5-9 present the biomechanical plots for the evaluate body areas. The graphs shows the expected trend of higher intrusion velocities directly connected with worse biomechanical results, and presented results that can be considered as good results considering the method applied (removal of internal trims, seat cushion friction and non-standard safety restraints). Abdomen area did not present the expected results, demonstrating a substantial variation, affecting this body area assessment. It was possible to obtain results that did not reach any score (9.5m/s case) until results that almost reached the maximum score (3.5m/s case).
